Sample Report

**Infrared Thermographic Survey
Of Electrical Switchgear
at the facilities of
Acme Computer Centers**

**RE: Infrared Survey of Electrical Switchgear
Acme Computer Centers – Center #1
Anytown, USA**

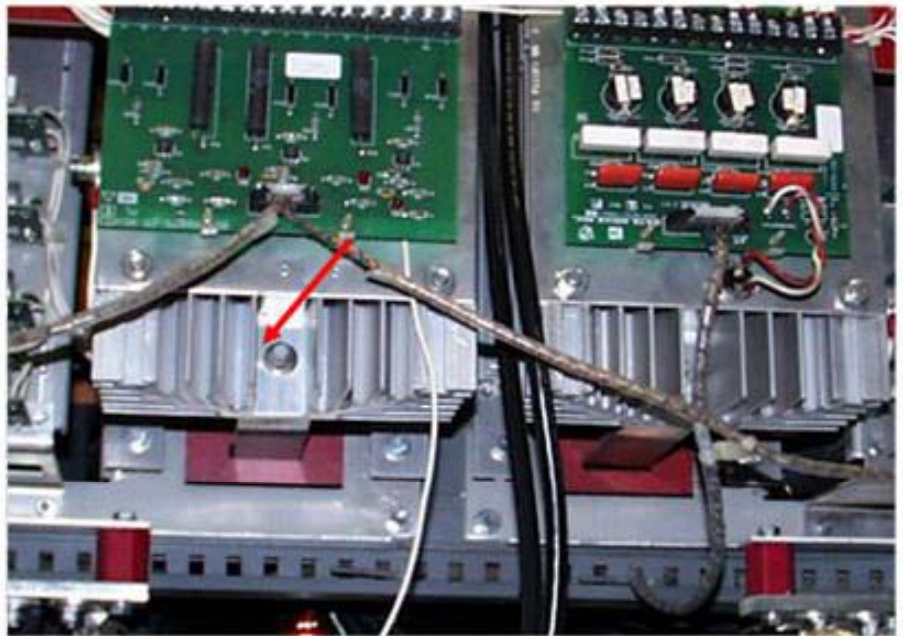
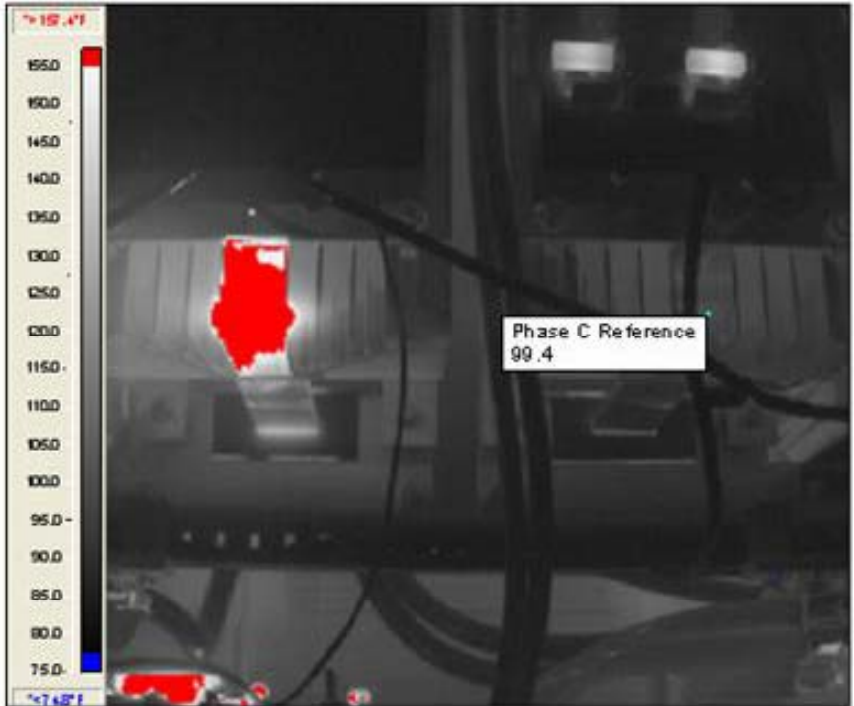
Report No. 1

AREA
UPS ROOM D/MODULE C-10

LOCATION
Panel A-B/Inverter Assembly

Ambient temp.	78.5
Reference temp.	99.4
High temp.	550.4
Temp. rise	451.0

Phase B/Lead Bolt to Main Bus.

TEMP. RATING	TEMP. RISE F degrees	CLASSIFICATION
Minor	1-18	Routine. Repair during regular maintenance, little chance of physical damage.
Alert	19-36	Repair within 30 days, watch load and inspect for physical damage.
Serious	37-54	Repair/Replace ASAP. Inspect surrounding components for physical damage.
*** CRITICAL	>55	IMMEDIATE REPAIR/REPLACE. DANGER EXISTS!

Replace All Damaged Components.

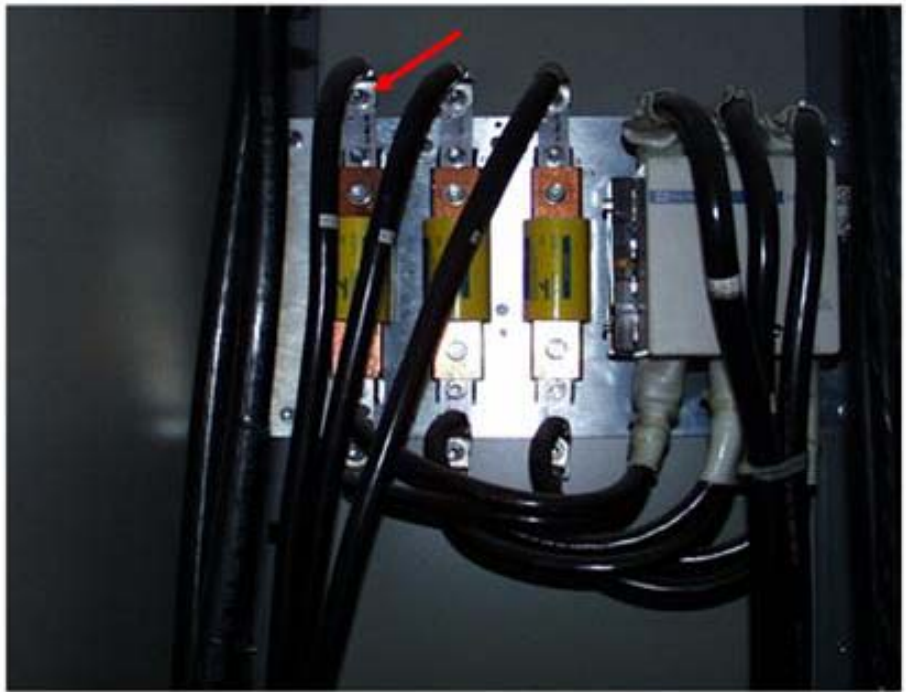
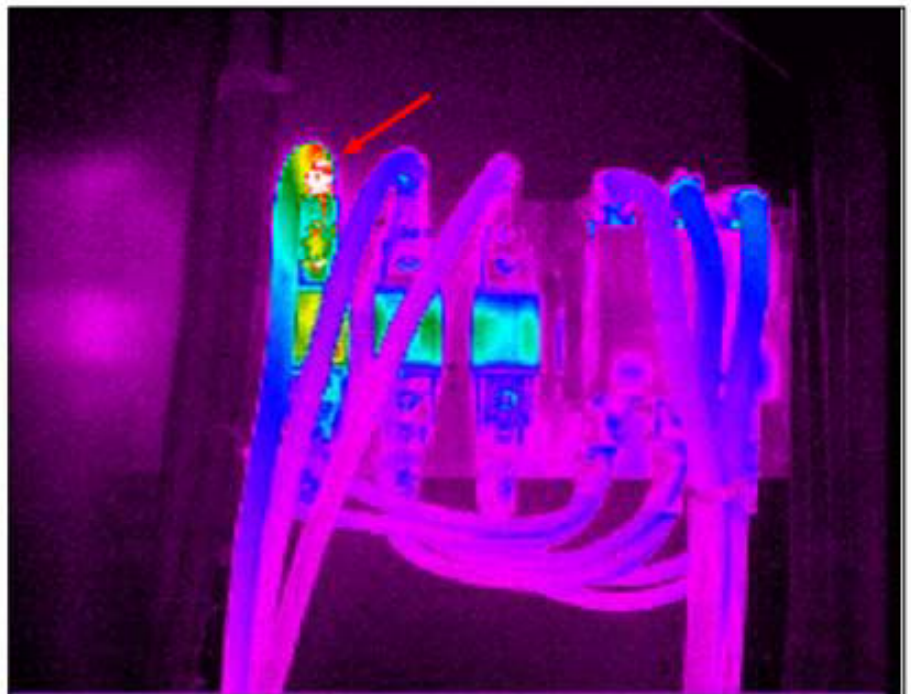
Report No. 2

AREA
UPS ROOM D/MODULE D-22

LOCATION
Panel A/Main Fuses

Ambient temp.	77.9
Reference temp.	83.6
High temp.	137.1
Temp. rise	53.5

Phase Left/Top Connections.

TEMP. RATING	TEMP. RISE F degrees	CLASSIFICATION
Minor	1-18	Routine. Repair during regular maintenance, little chance of physical damage.
Alert	19-36	Repair within 30 days, watch load and inspect for physical damage.
*** Serious	37-54	Repair/Replace ASAP. Inspect surrounding components for physical damage.
CRITICAL	>55	IMMEDIATE REPAIR/REPLACE. DANGER EXISTS!

Check Connections.

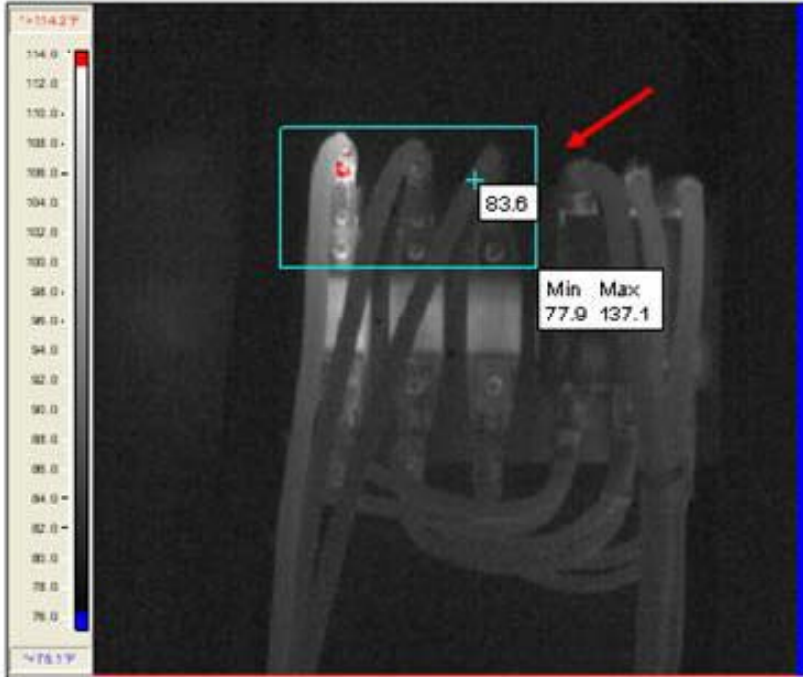
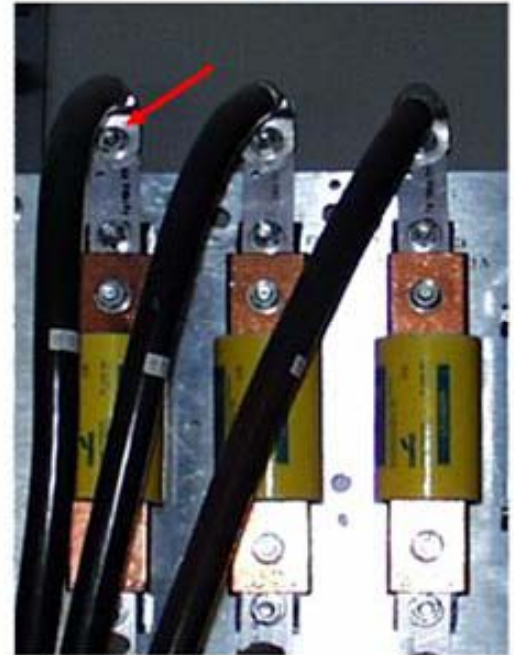
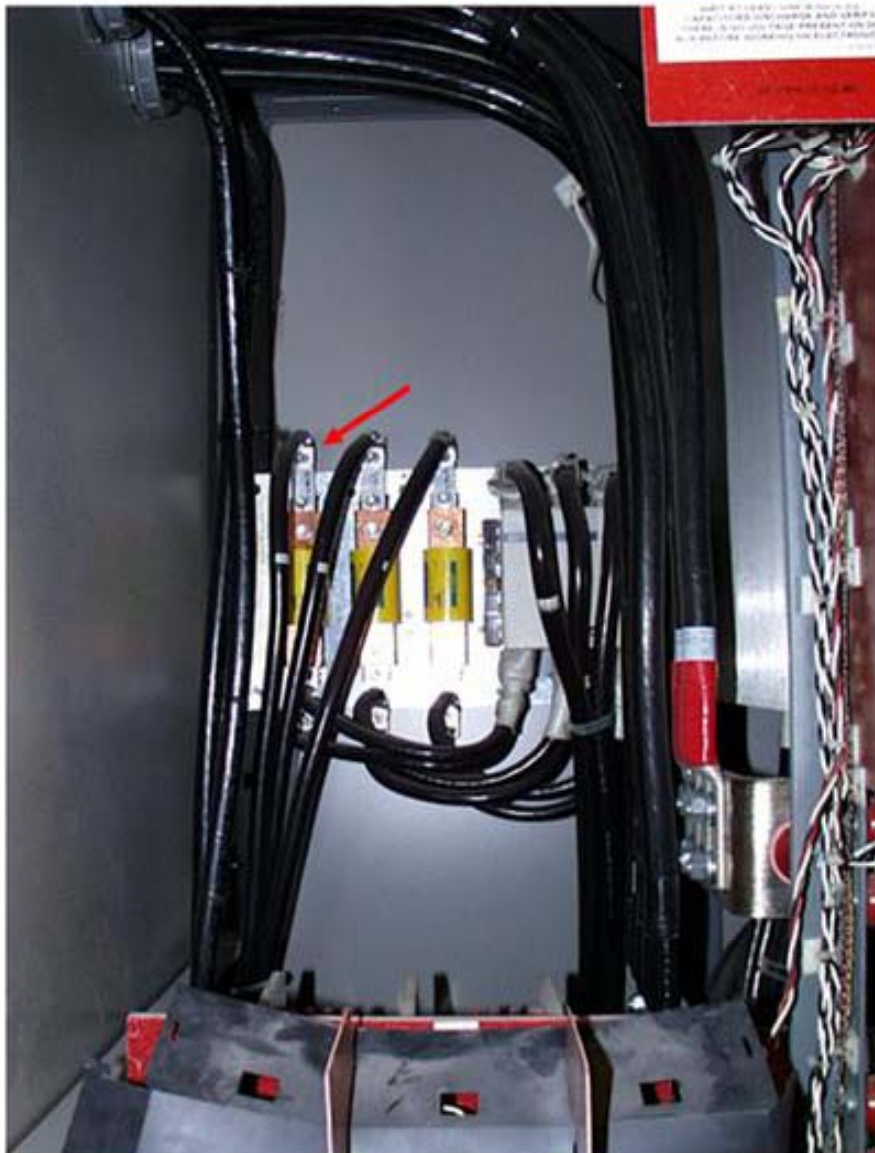
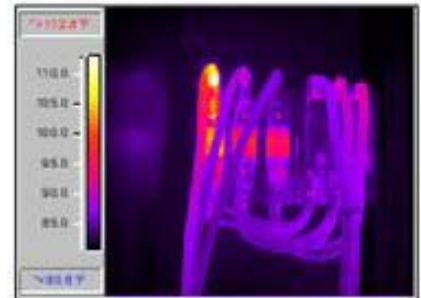
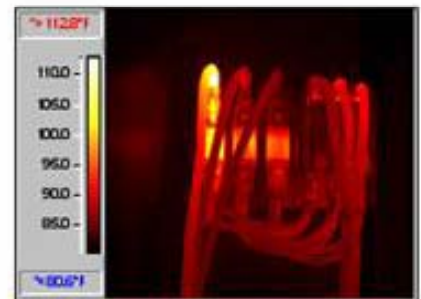
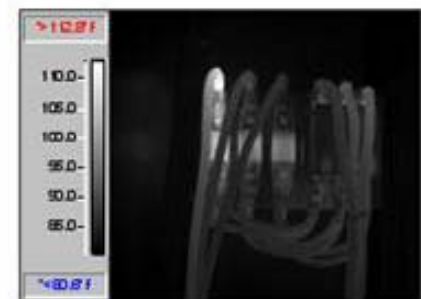
Report No. **2** (CON'T)

Area: UPS ROOM D/MODULE D-22
Loc: Panel A/Main Fuses

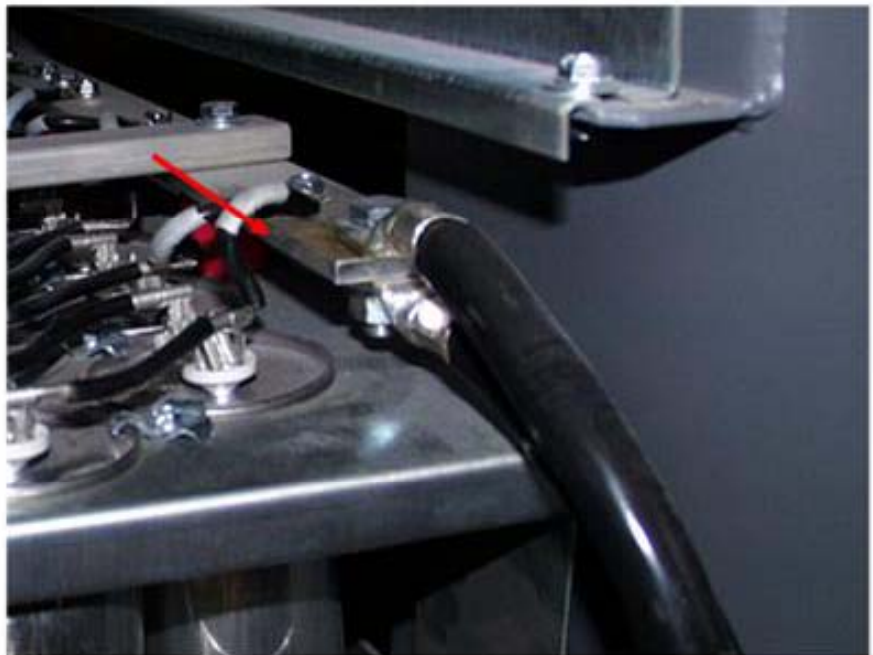
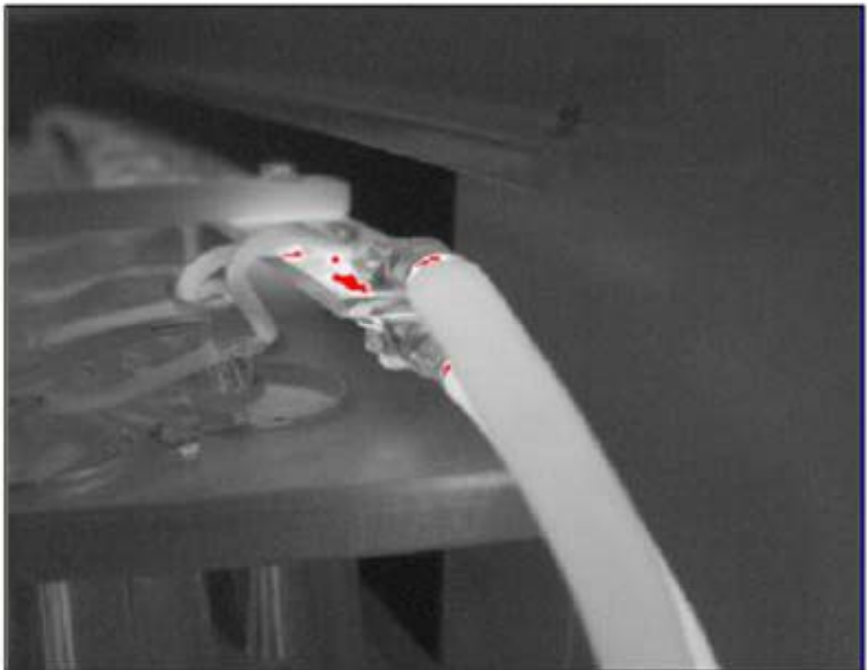
Report No. 3

AREA
UPS ROOM #1/MODULE #45

LOCATION
Panel 3 Output Filter Assembly

Ambient temp.	75.0
Reference temp.	79.0
High temp.	125.7
Temp. rise	46.7

Phase B/Cable Lug Connection.

<u>TEMP. RATING</u>	<u>TEMP. RISE</u> F degrees	<u>CLASSIFICATION</u>
Minor	1-18	Routine. Repair during regular maintenance, little chance of physical damage.
Alert	19-36	Repair within 30 days, watch load and inspect for physical damage.
*** Serious	37-54	Repair/Replace ASAP. Inspect surrounding components for physical damage.
CRITICAL	>55	IMMEDIATE REPAIR/REPLACE. DANGER EXISTS!

Check Bolted and Crimped Connections.

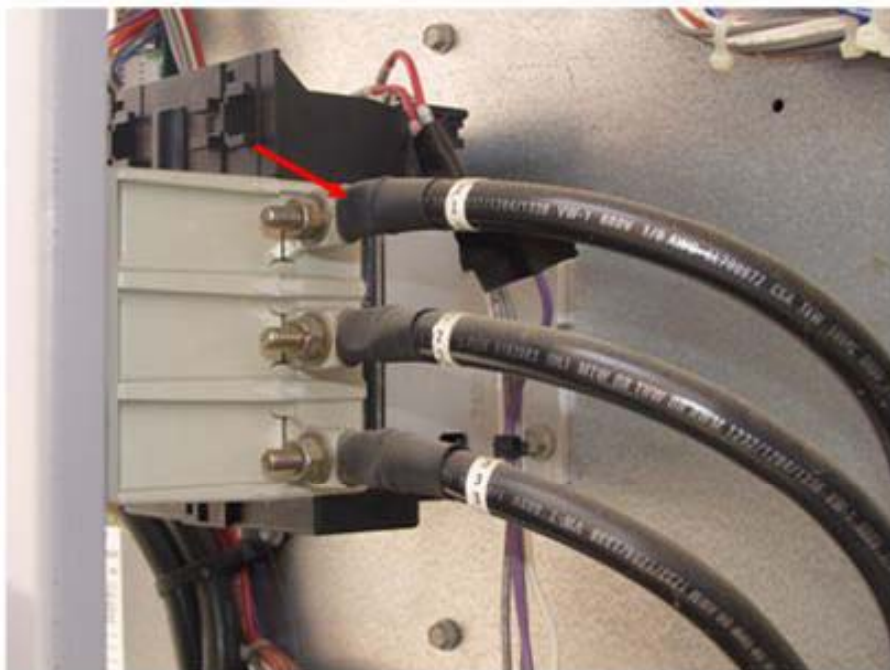
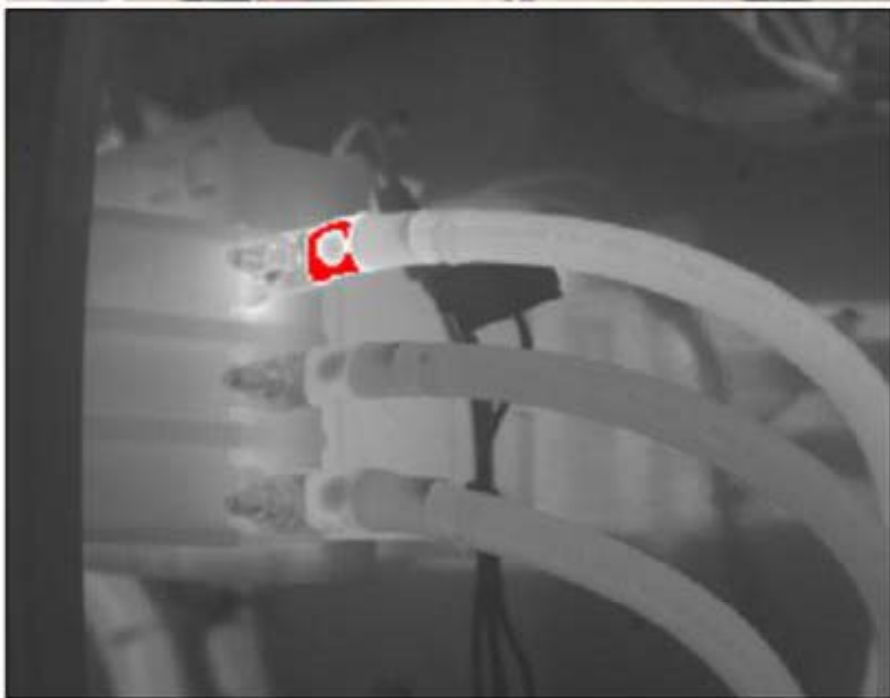
Report No. 4

AREA
CHILLER PAD/CHILLER CH-2

LOCATION
Starter Pnl/Contactor #2

Ambient temp.	95.2
Reference temp.	108.0
High temp.	138.0
Temp. rise	30.0

Phase A:	99
Phase B:	96
Phase C:	99

Contactor connector overheating.

TEMP. RATING	TEMP. RISE F degrees	CLASSIFICATION
Minor	1-18	Routine. Repair during regular maintenance, little chance of physical damage.
*** Alert	19-36	Repair within 30 days, watch load and inspect for physical damage.
Serious	37-54	Repair/Replace ASAP. Inspect surrounding components for physical damage.
CRITICAL	>55	IMMEDIATE REPAIR/REPLACE. DANGER EXISTS!

Reinstall wire, check connection.

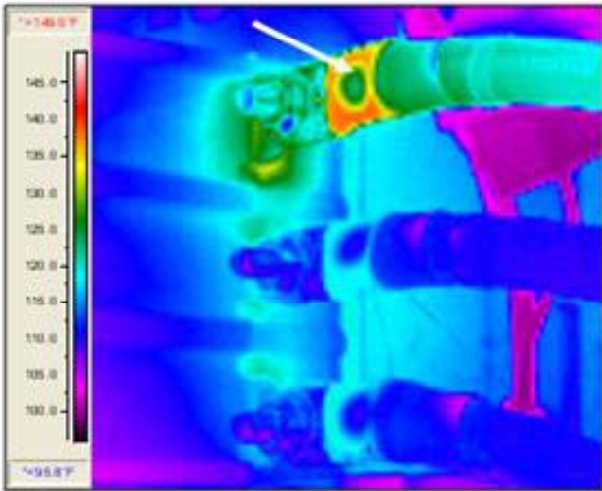
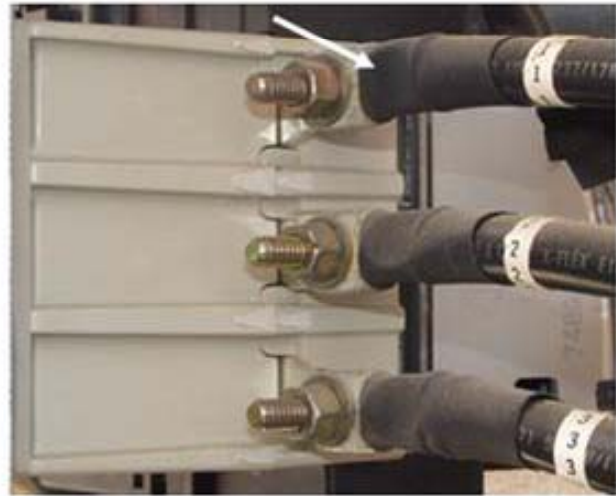
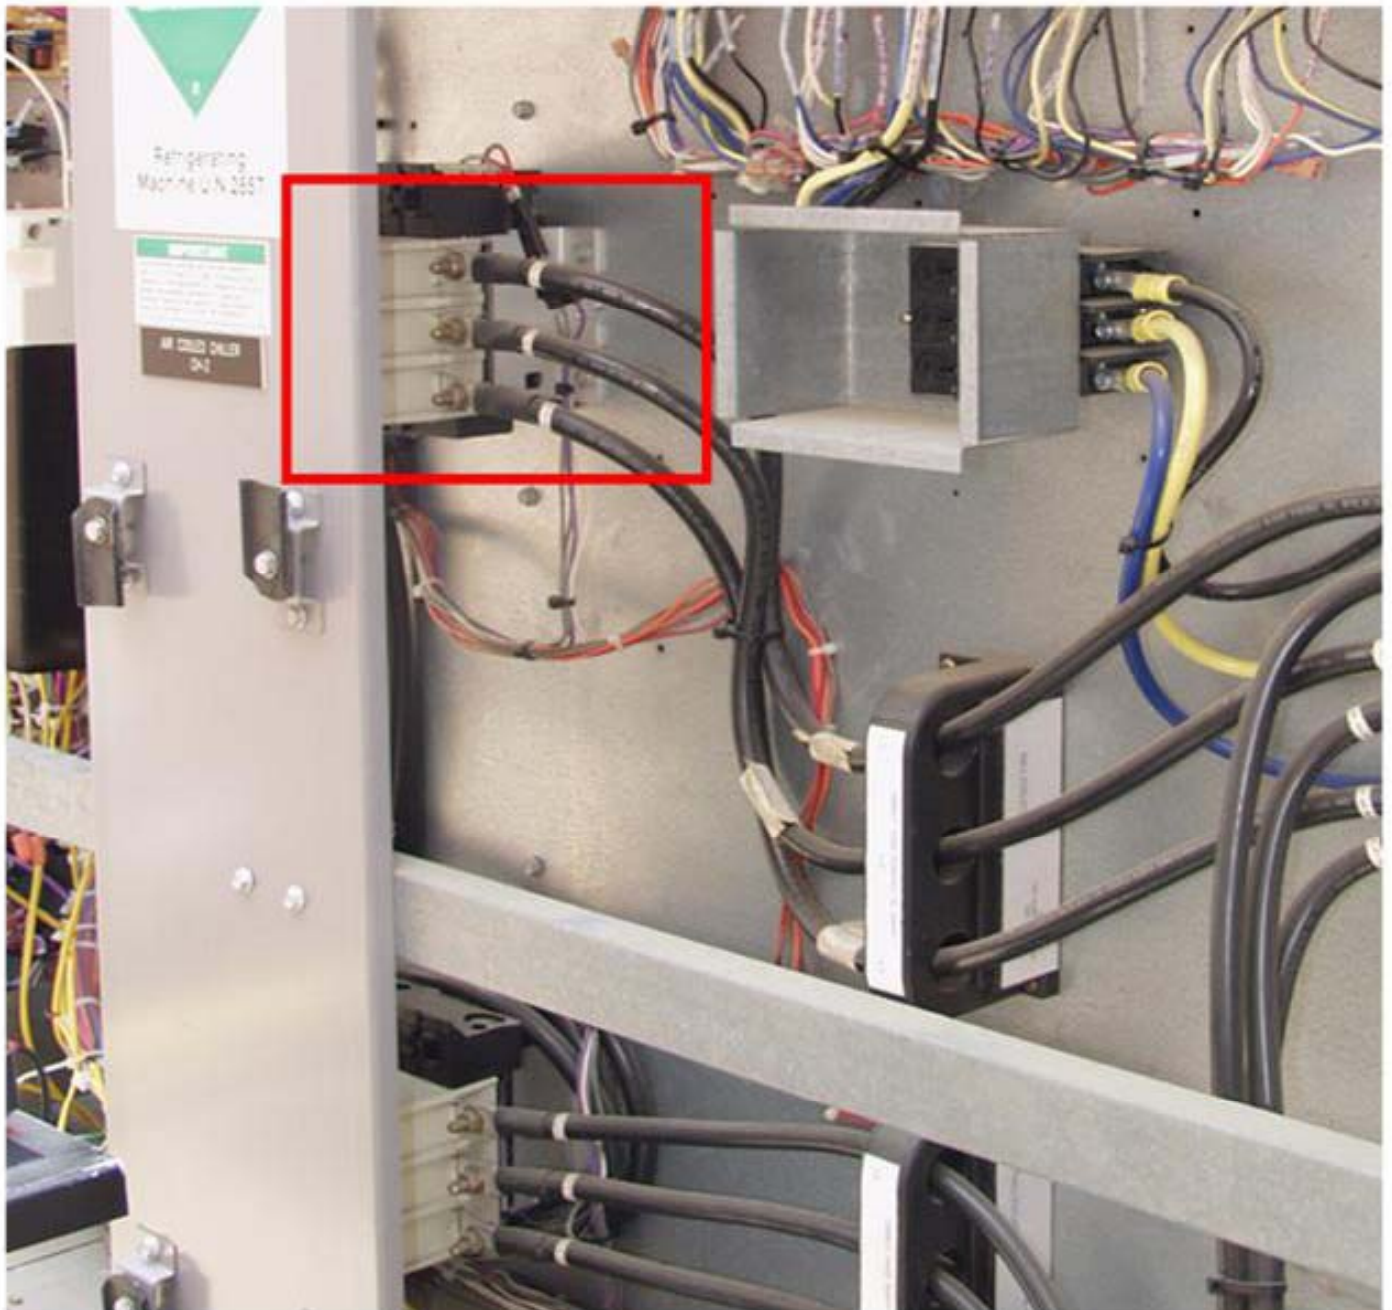
Report No. 4 (CON'T)

Area: CHILLER PAD/CHILLER CH-2
Loc: Starter Pnl/Contactor #2

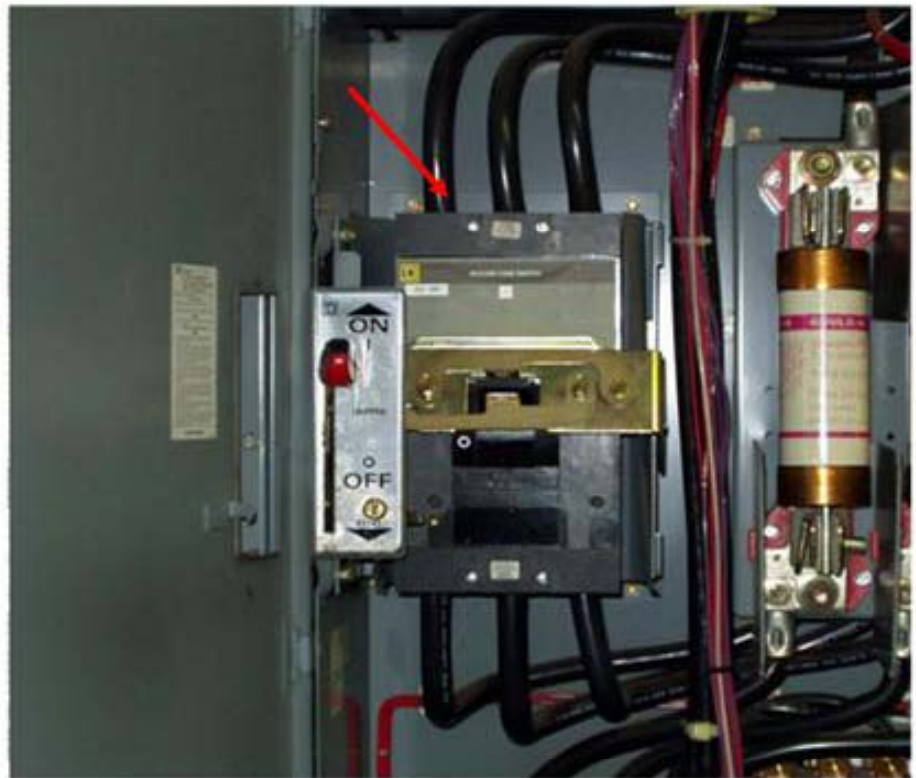
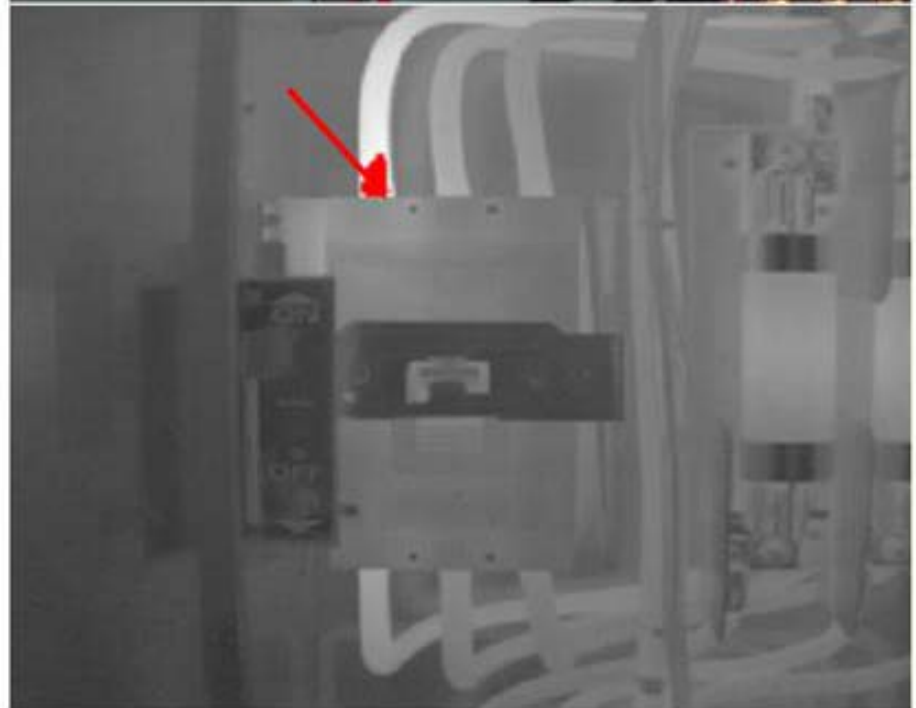
5

MAIN SWGR RMMCC-A

Cubicle A1/COMP RM Fan #1

Temp. rise 52.0

Breaker lug/phase A, line side.

<u>TEMP. RATING</u>	<u>TEMP. RISE</u> F degrees	<u>CLASSIFICATION</u>
Minor	1-18	Routine. Repair during regular maintenance, little chance of physical damage.
Alert	19-36	Repair within 30 days, watch load and inspect for physical damage.
*** Serious	37-54	Repair/Replace ASAP. Inspect surrounding components for physical damage.
CRITICAL	>55	IMMEDIATE REPAIR/REPLACE. DANGER EXISTS!

Check breaker lug and connections.

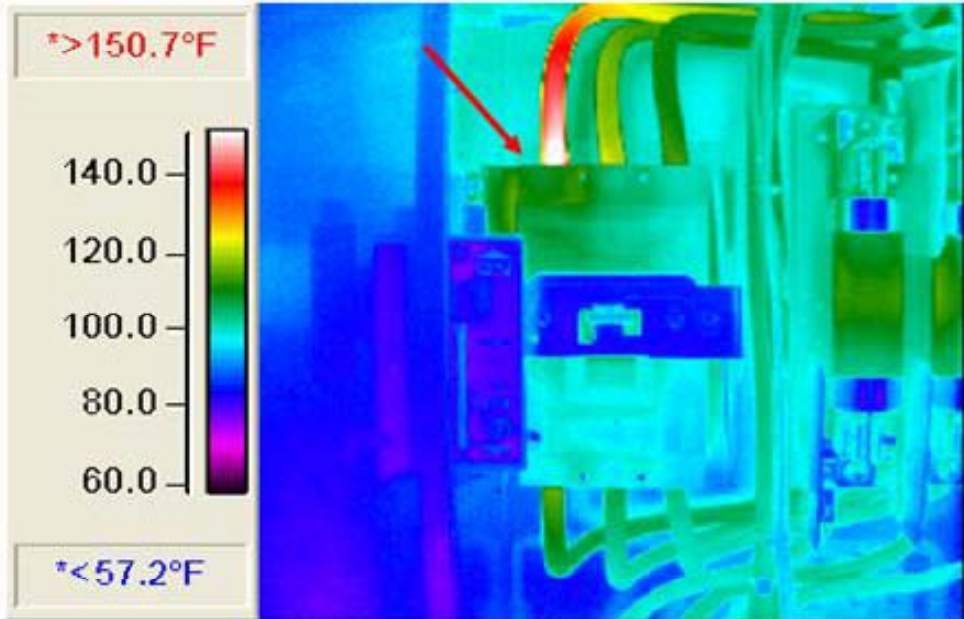
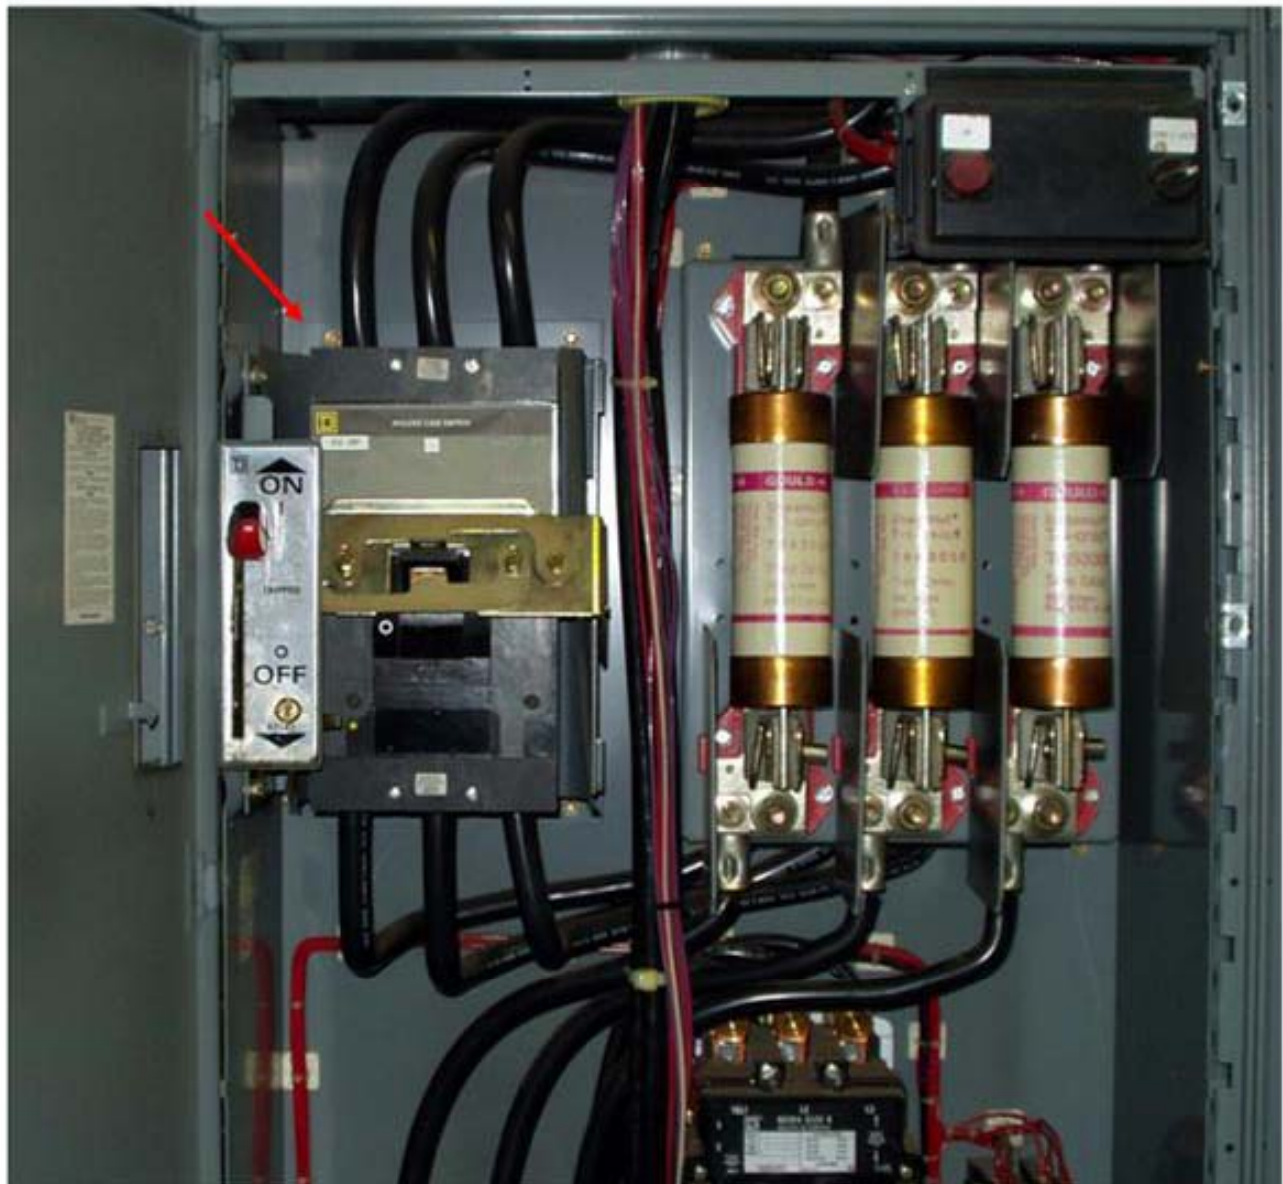
Report No. **5** (CON'T)

Area: MAIN SWGR RM/MCC-A
Loc: Cubicle A 1/COMP RM Fan #1

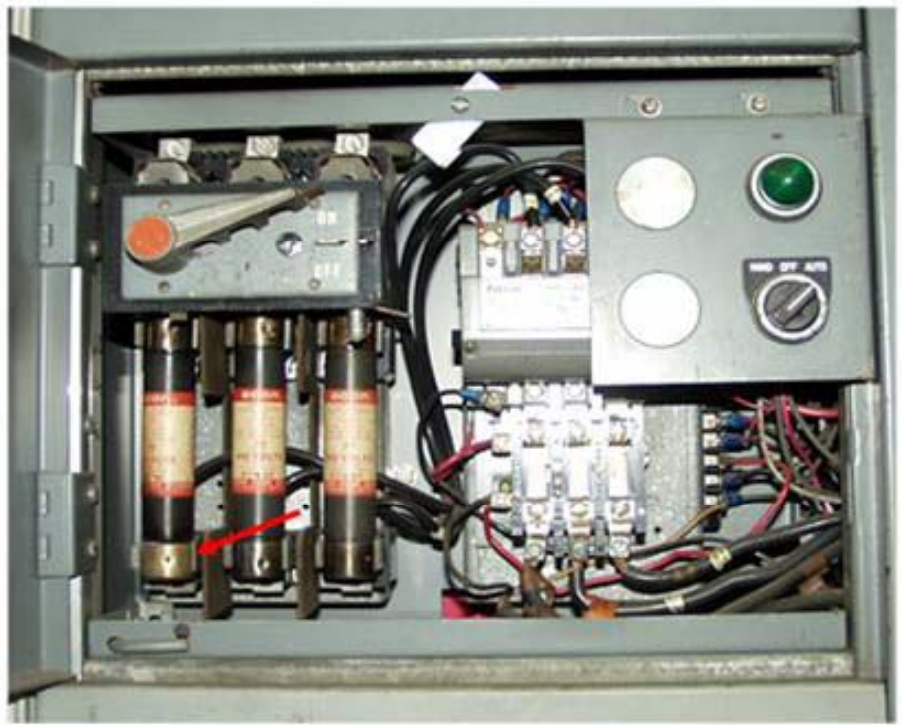
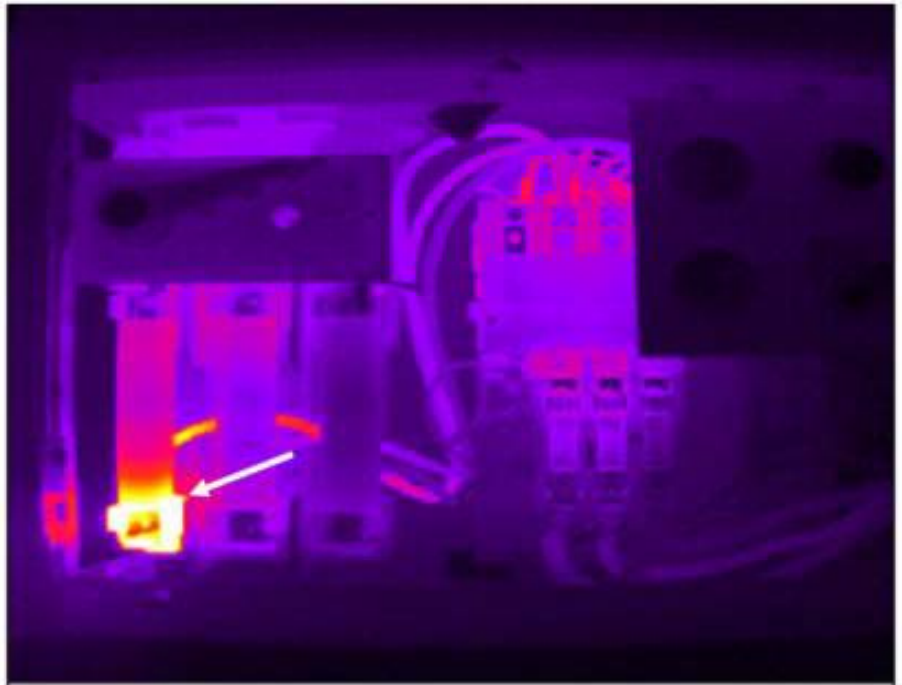
Report No. 6

AREA
MAINMCR #3MCC #3-2

LOCATION
Cubicle D2/Pump 3B

Ambient temp.	86.0
Reference temp.	104.8
High temp.	224.2
Temp. rise	119.4

Phase A:	30
Phase B:	28
Phase C:	29

DESCRIPTION
Fuse and fuse clip/phase A, load side.

TEMP. RATING	TEMP. RISE F degrees	CLASSIFICATION
Minor	1-18	Routine. Repair during regular maintenance, little chance of physical damage.
Alert	19-36	Repair within 30 days, watch load and inspect for physical damage.
Serious	37-54	Repair/Replace ASAP. Inspect surrounding components for physical damage.
*** CRITICAL	>55	IMMEDIATE REPAIR/REPLACE. DANGER EXISTS!

RECOMMENDATION
Replace fuse and fuse clip.

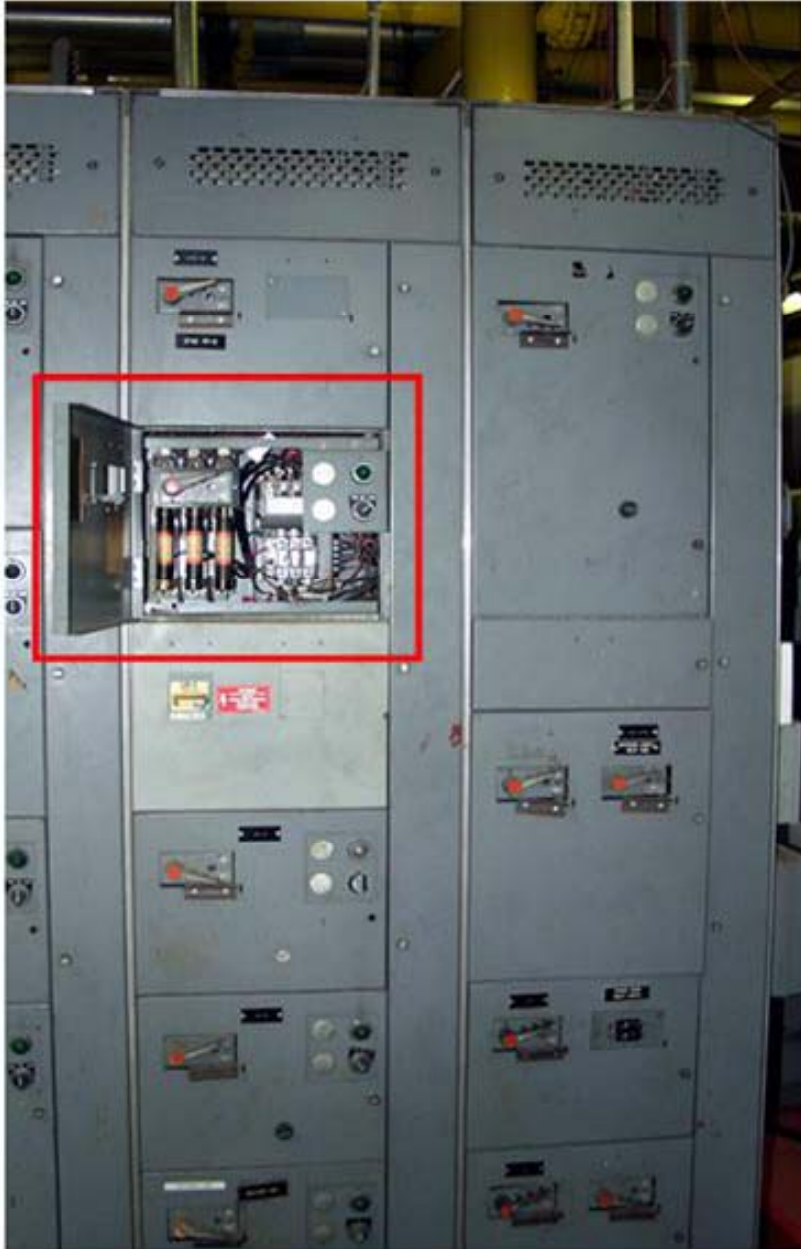
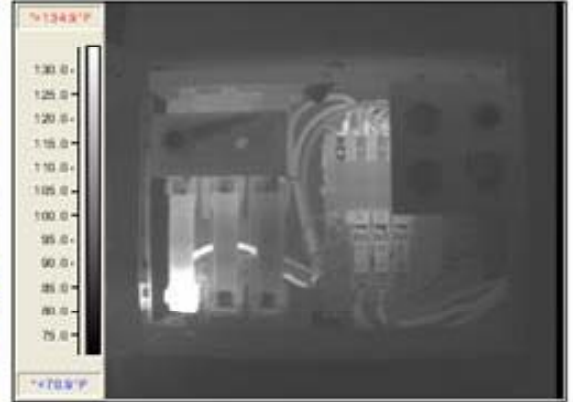
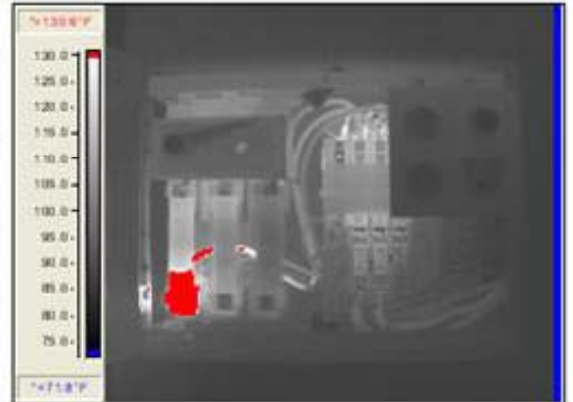
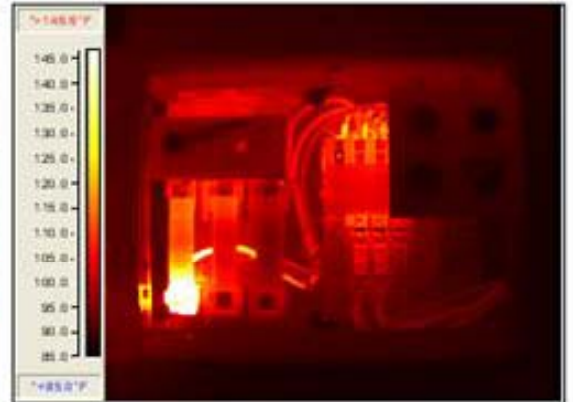
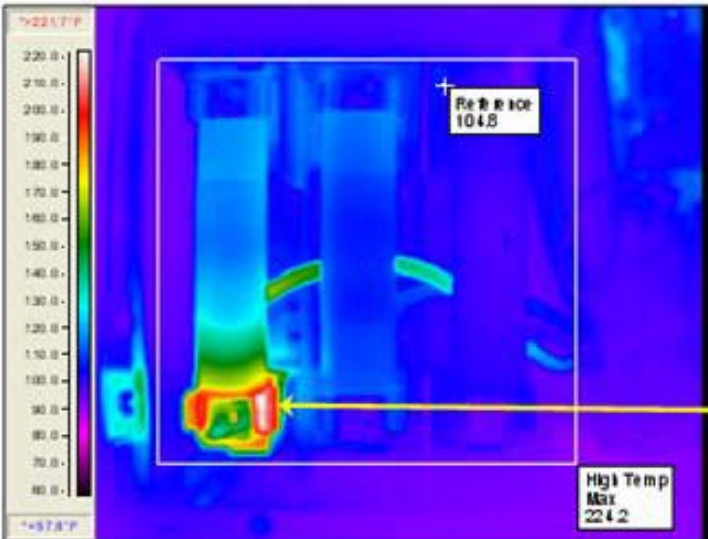
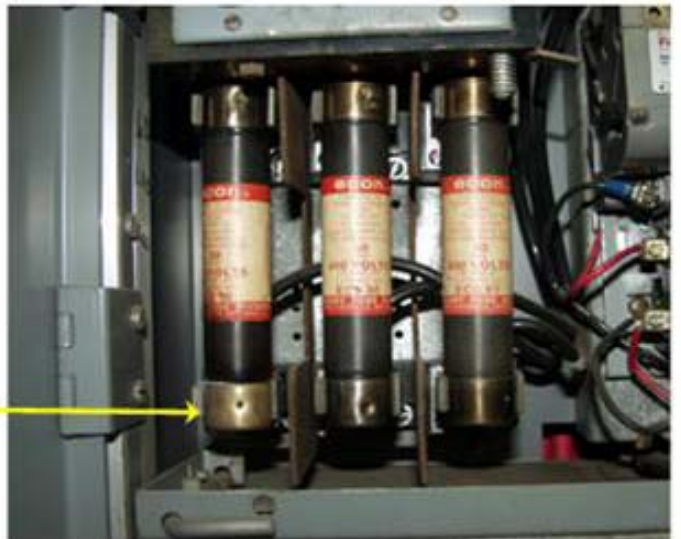
Report No. **6** (CON'T)

Area: MAINMCR #3MCC #3-2
Loc: Cubicle D2/Pump 3B
